Observations on the Construction System of the 18th Century Bastion Fortification in Timișoara

ALEXANDRU SZENTMIKLOSI

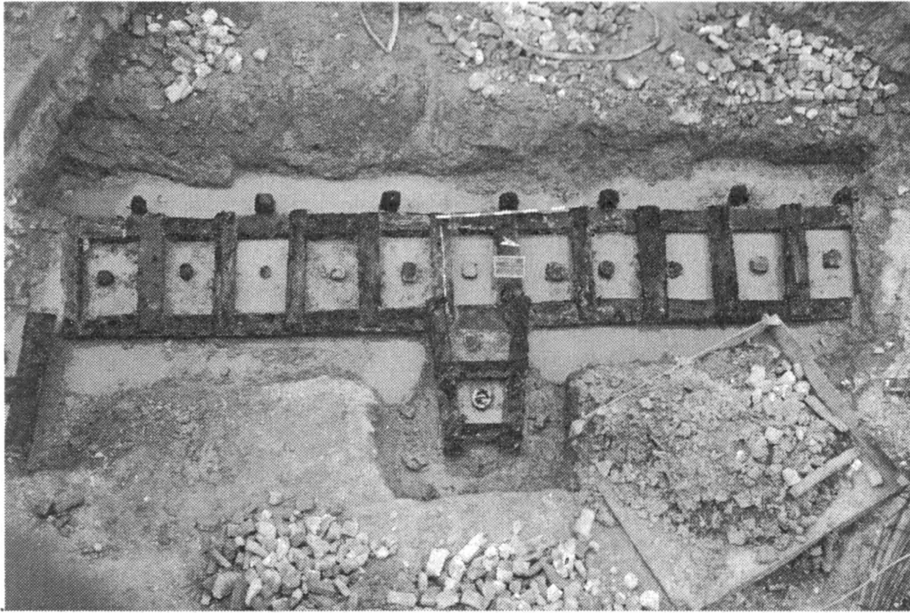
1.

PLATE III: 1 – The digitized profile of the ditch defense in front of Counterguard I; 2 – The connection between Counterguard I and Redan II with the flooding channel of the defense moat; 3 – Detail of the pillars blocking the access through the canal.

Before each of the counterguards there was a moat whose width was about 18 m. In the middle of the moats, there were arranged flooding cunettes which, in case of a siege,²² were filled with water from the Bega (Plate III/1). Communication between the cunettes was facilitated by the existence of connecting passageways, like that found in Precinct B, sectioned through the brick walls that enclosed the external fortifications of the city (Plate III/2). To prevent access from one sector to another, these passageways were blocked by pillars beaten in clay that allowed only the passage of water (Plate III/3). The traces of stagnant water in the moats were captured in all the profiles documented by preventive archaeological research. In the northern part of Counterguard I, the connecting passageway was protected by a brick structure leaning against it, in the shape of the letter “U,” whose southern side also represented the closing wall of the counter-guard. The walls of this structure flanked the connecting passageway between the cunettes.

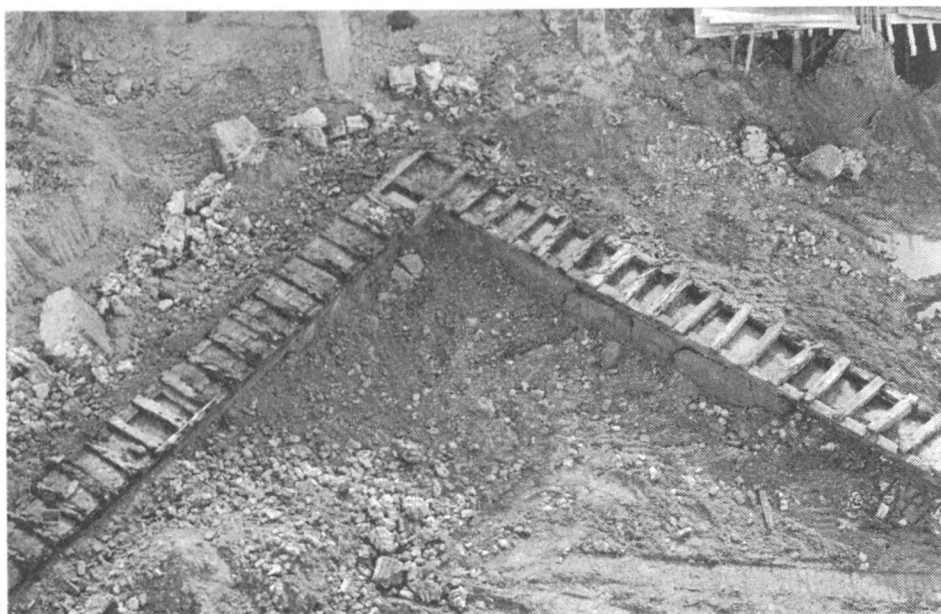
PLATE IV: 1 – The wooden substructure mounted on pillars in the southern half of Counterguard I (City Business Center, Building D); 2 – The wooden substructure directly on the yellow clay, in the northern half of Counterguard I (The 700 Square underground parking area).

Unlike the southern sector of Counterguard I, where the wooden foundation footing was attached to poles thrust into the ground (*Plate IV/1*), in the northern half, the wooden substructure of Counterguard I was deposited directly on clay (*Plate VI/2*). It may well be that this construction difference was due to the different terrain, the ground-water level being probably higher on the southern side.

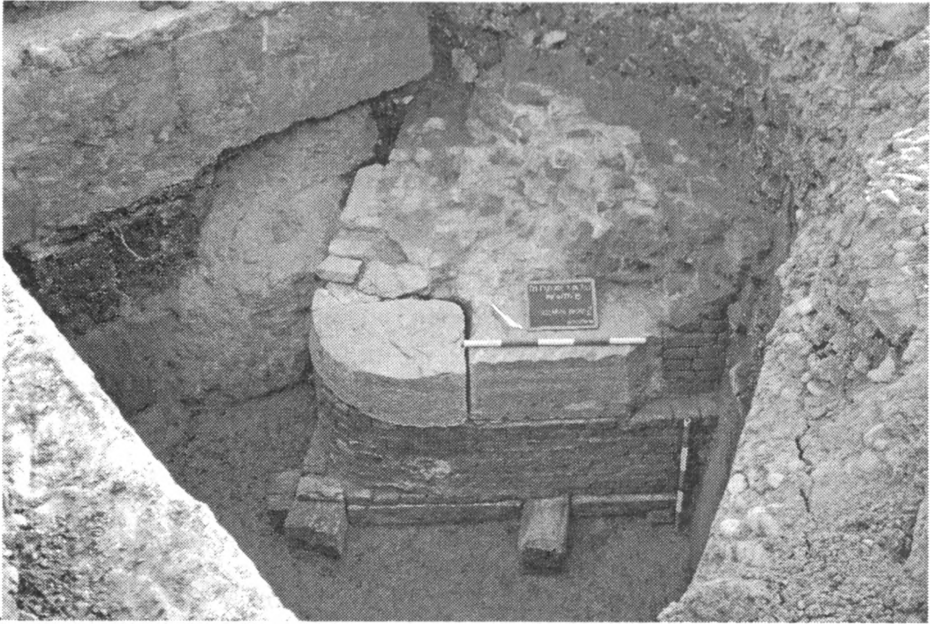
1.

PLATE V: 1 – The unitary construction concept of Counterguard I and Redan II; 2 – Fragment from the scarp of Counterguard VII, destroyed by the construction of the waterproofing wall for Precinct B (The 700 Square underground parking area).

Represented on some maps as separate sectors, Redan II and Counterguard I were organically connected by the wooden substructure that supported the foundation. The only difference in the building technique was the brick threshold that marked the boundary between the straight wall of the foundation and tilted wall forming the scarp. While the scarps of Counterguards I and VII and of Redan II had a demarcation threshold consisting of a row of bricks arranged horizontally, with the width outward, the threshold of the slurry wall from the rear of Counterguard I and the walls flanking the connecting passageway between the cunettes consisted in a row of bricks that were laid on edge, with the width on the outside.
